## An IPS e.max CAD single crown – Tooth 16, in 60 minutes

### Case Description

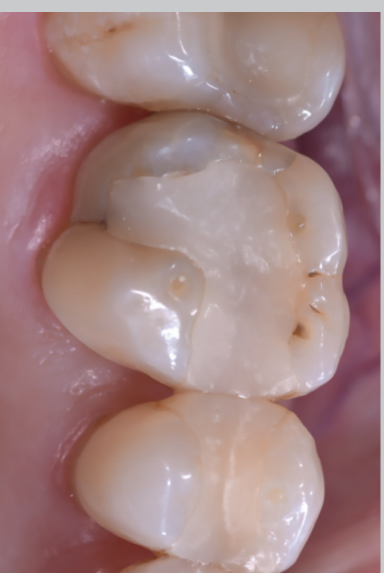
#### Before:

Large insufficiency of the composite filling on tooth 16 with distal marginal ridge cracks, a lingual wall crack and distal recurrent decay.

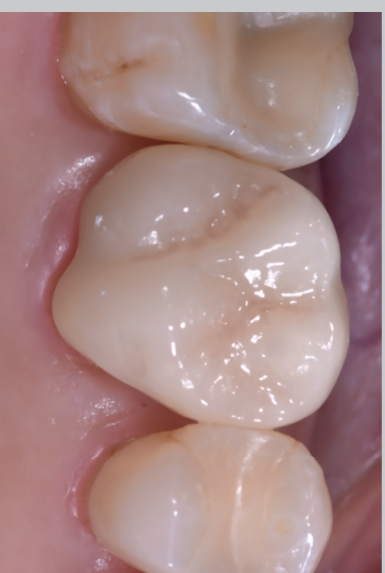
#### After:

High esthetic full-surface glass-ceramic crown.
